## ADDENDUM NO. 2

PROJECT: Hell Creek State Park Infrastructure Upgrades

# **GEOTECHNICAL EVALUATION REPORT**

**Proposed Water and Wastewater  
Treatment System Improvements  
Hell Creek State Park  
North of Jordan, Montana  
Project 17-3585G**

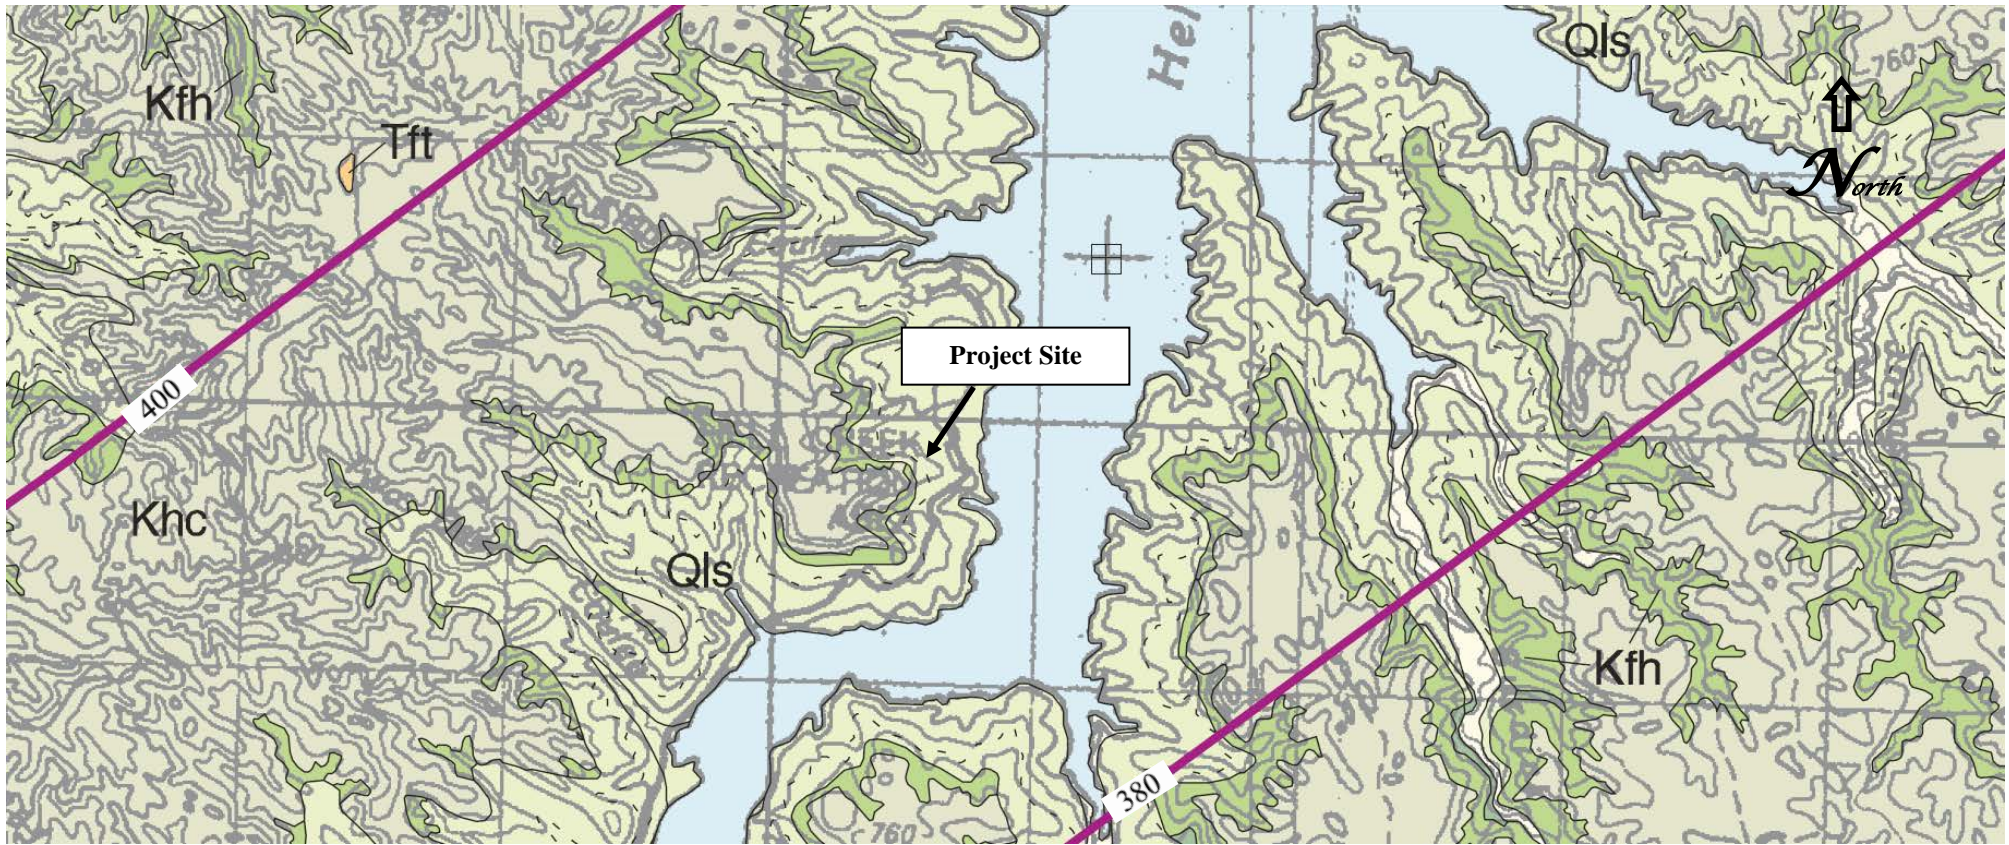
## MAP UNITS

Khc	Hell Creek Formation
Kfh	Fox Hills Formation
Qls	Landslide deposit

Drawn by:	Google Earth/SKG	Date	8/16/17
Project:	17-3585G		
Scale:	NTS		FIGURE
Sheet	1	of 1

As can be seen on the attached Geologic Sketch, the entire shoreline of Fort Peck Lake in the Hell Creek State Park area is mapped as "landslide deposits." Active landslides can readily be seen in the residential area upslope and north of the marina. These landslides have caused distress to several of the buildings. Although a geotechnical reconnaissance was not part of our scope of services, we are not aware of any active landslides in the proposed improvement areas. Even so, it is critical all members of the ownership, design, construction, and development team recognize there is a risk the project could activate landslides.

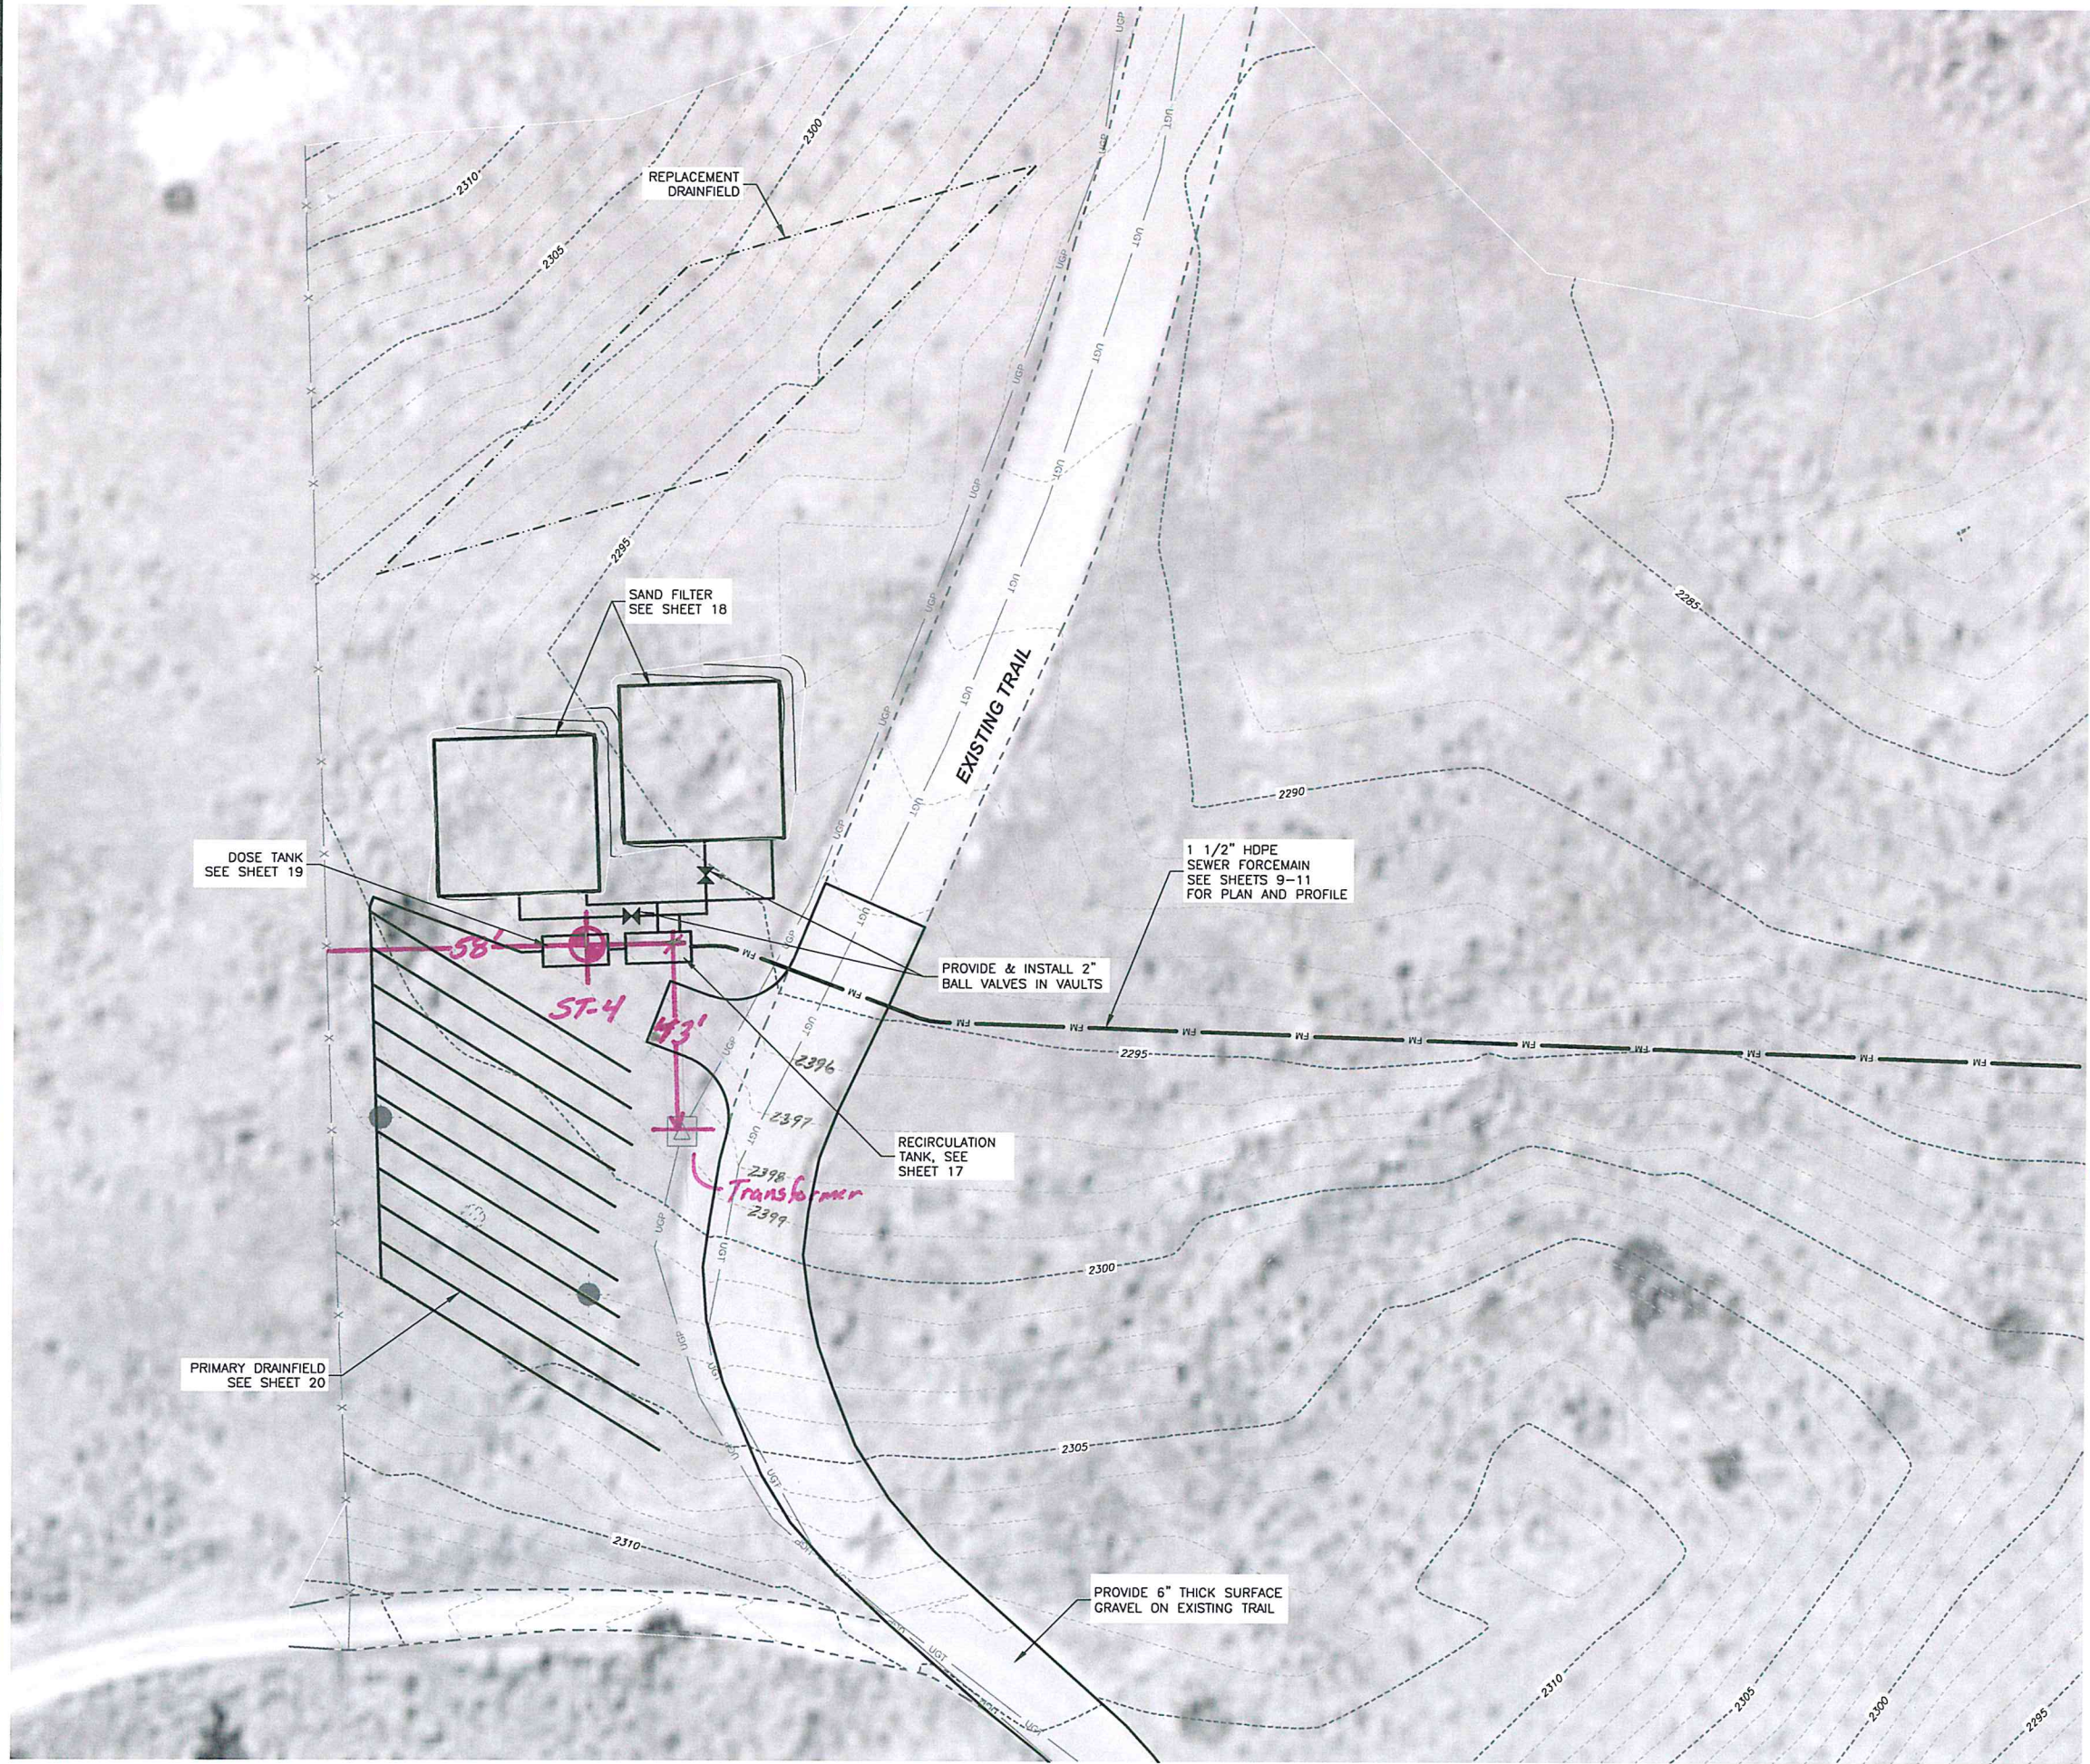
BORING LOCATION SKETCH  
BORING ST-4  
Drainfield Area

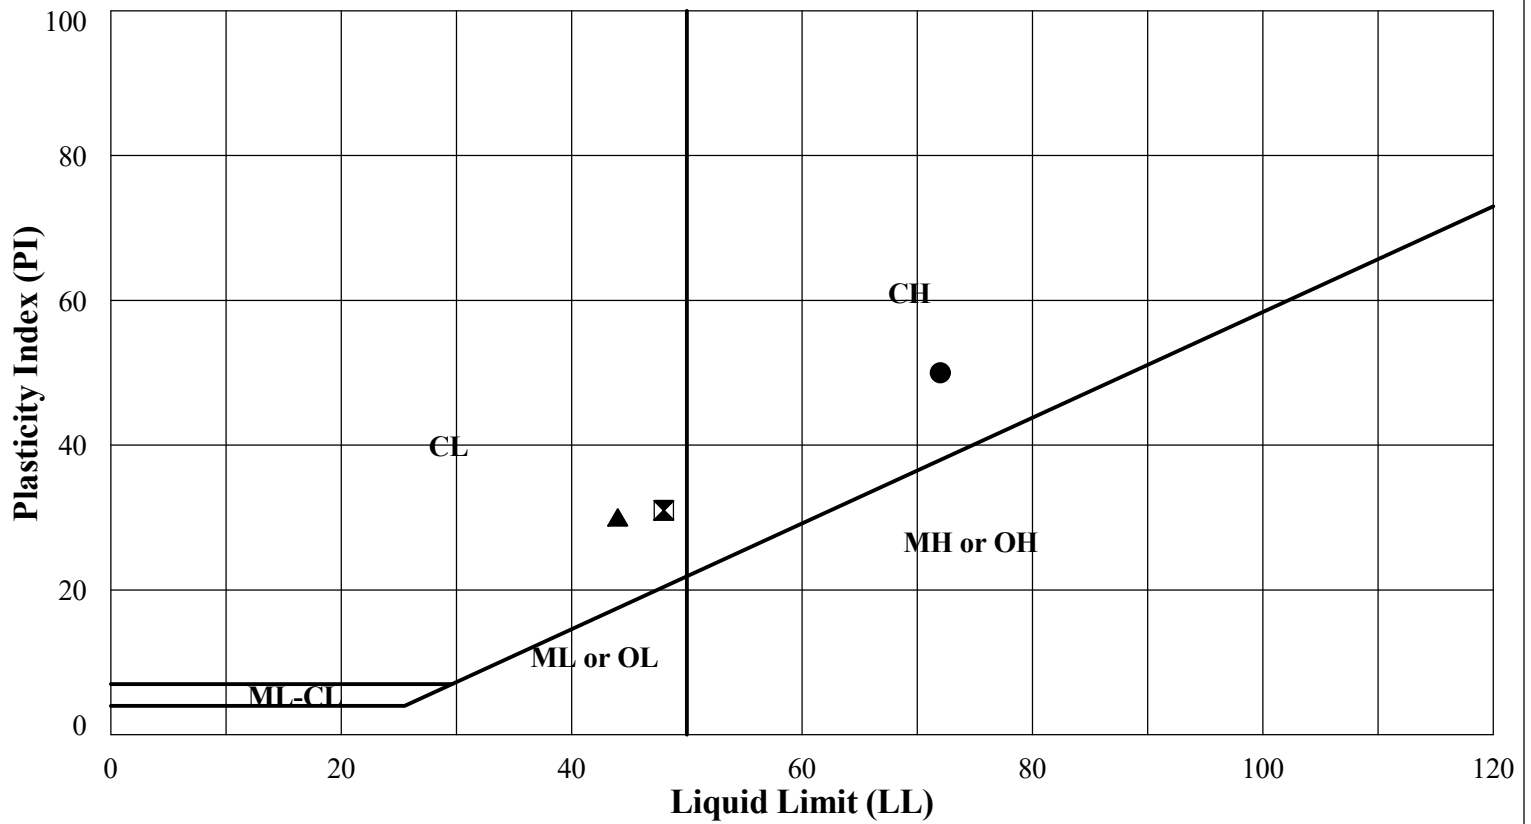
Legend	Boring	Sample No.	Depth	LL	PL	PI	P 200	MC	Classification
●	ST-1	TW	13' to 14'	72	22	50	98%	28.3%	CH
⊠	ST-2	P-1	1' to 5'	48	17	31	93%	6.9%	CL
▲	ST-2	TW	3' to 4'	44	14	30	95%	11.4%	CL

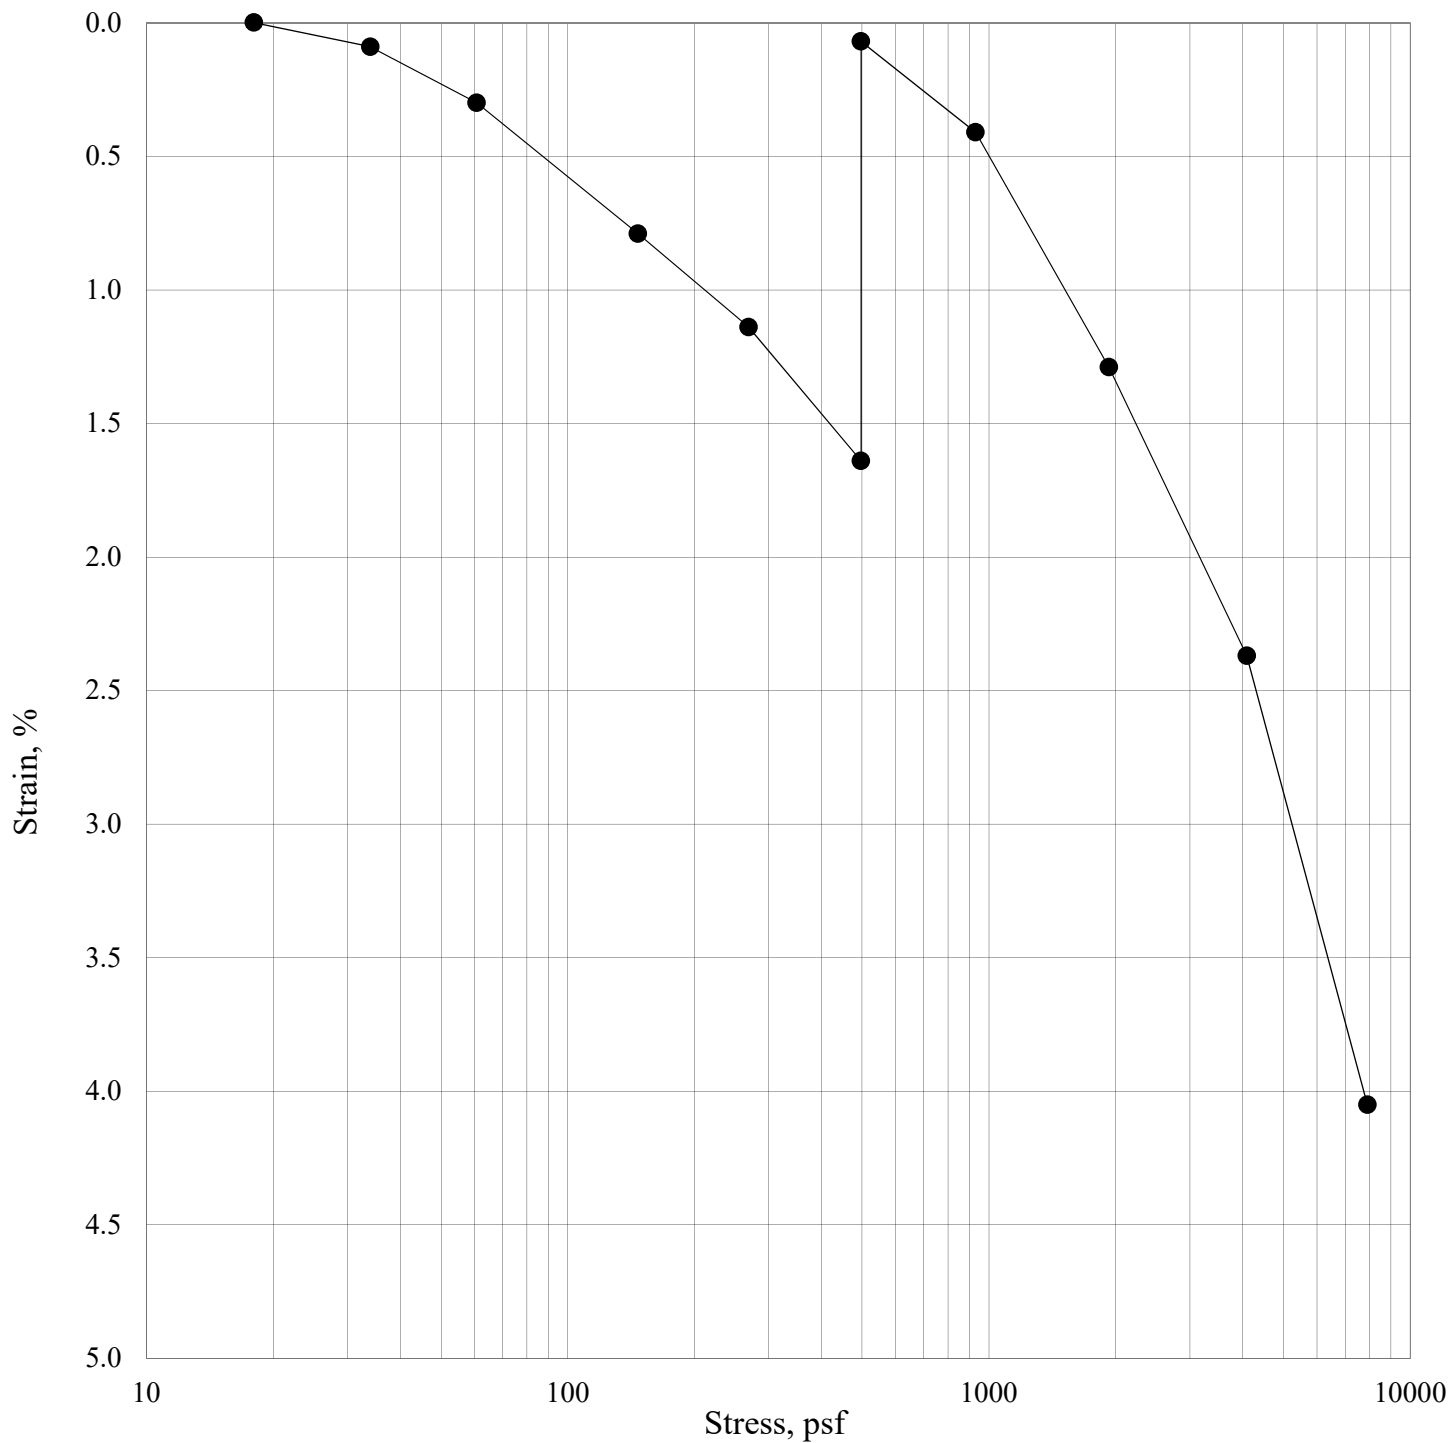
Boring No.	ST-1	Depth:	13 - 14 '	<u>Initial Dry Density (pcf)</u> <b>93.6</b>	<u>Initial Moisture Content (%)</u> <b>28.3</b>
Sampled By:	Drill Crew	Date Received:	8/15/17		
Soil Description: SHALE (Soil Class: Fat Clay (CH), high plasticity, trace slickensides, schist, olive brown, moist.

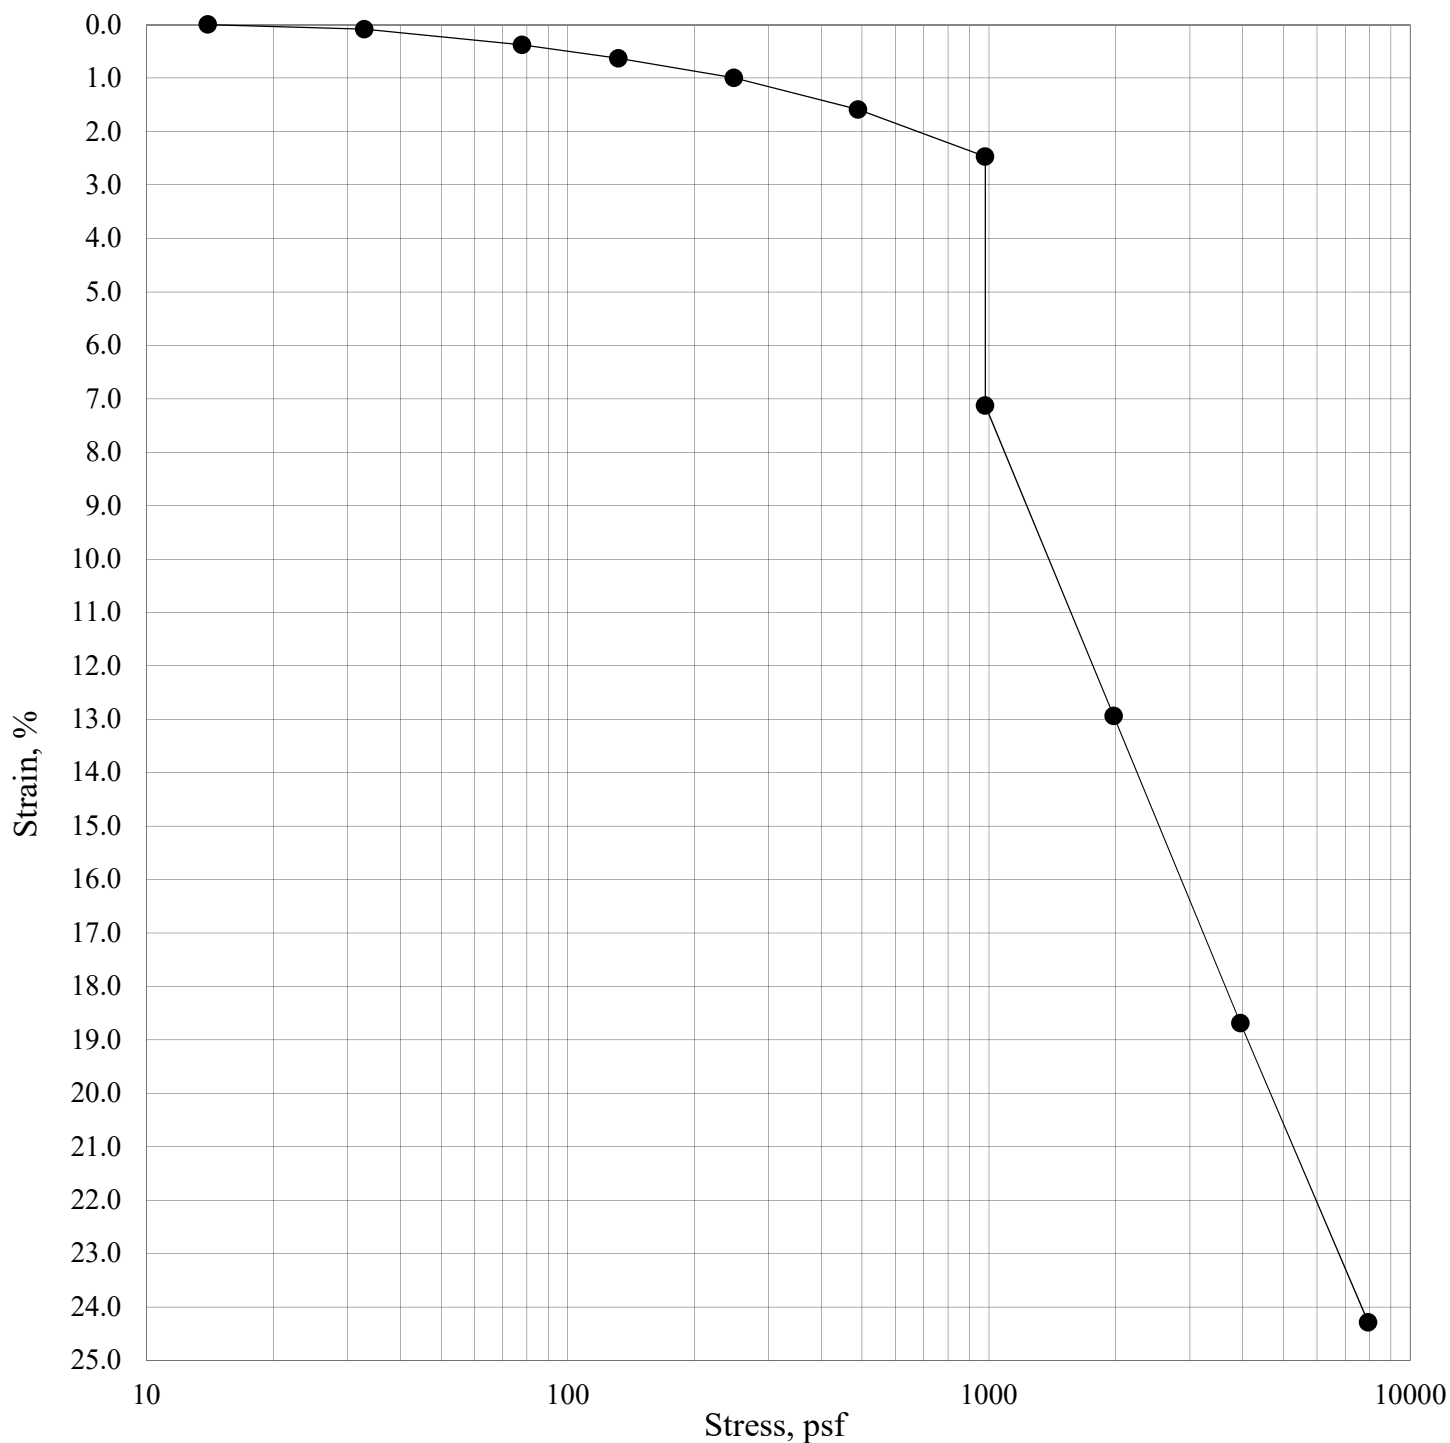
Boring No.	ST-2	Depth:	3.0'-4.0'	Initial Dry Density (pcf) <b>81.1</b>	Initial Moisture Content (%) <b>11.4</b>
Sampled By:	Drill Crew	Date Received:	8/14/17		
Soil Description: Lean Clay (CL), medium plasticity, trace salts, roots, pinholes, light olive brown, moist.

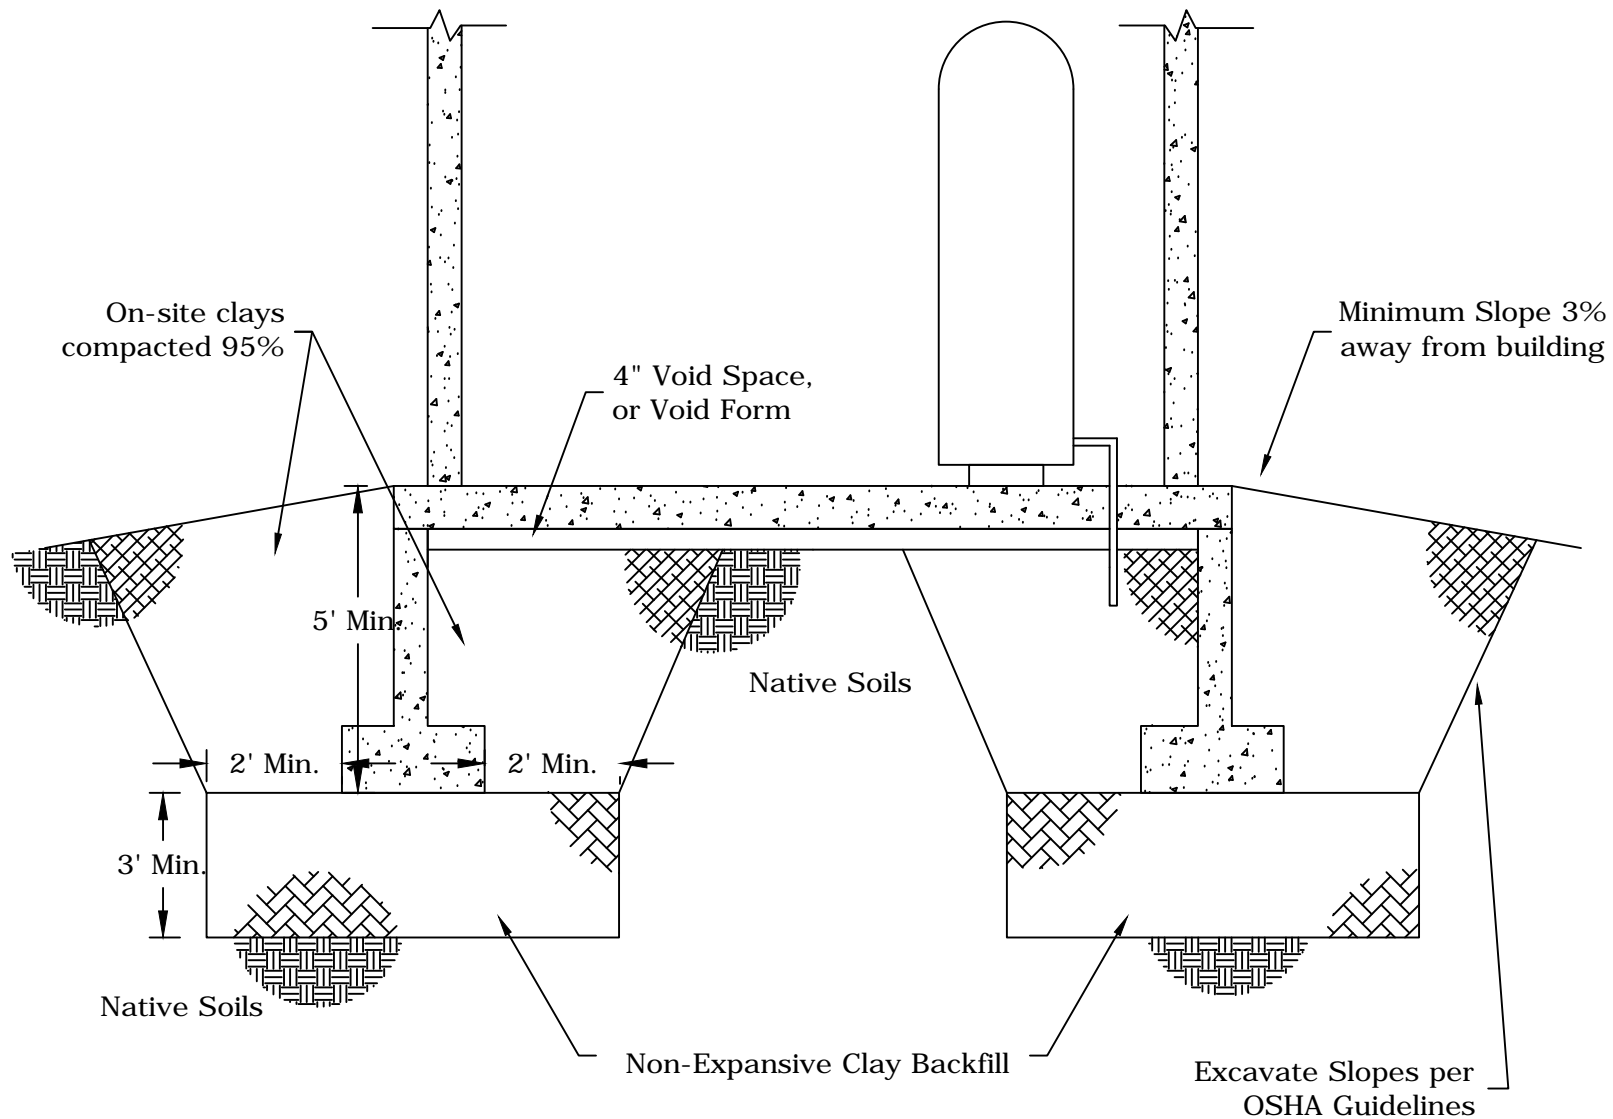
## Detail 2. Pump Building

We do not recommend installing floor drain through floor slab into subgrade.
